PARAJET TECHNICAL ADVISORY BULLETIN

OCTOBER 2022 - UPRATED FUEL CAP REPLACEMENT

PJ-P-10088 : Fuel Tank Cap

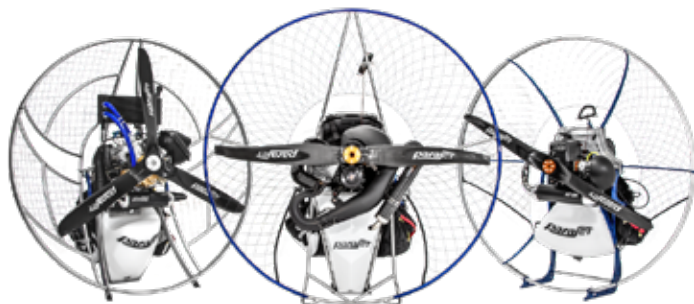
fitted to Parajet Maverick, Zenith and Volution 3 paramotor airframes.

Parajet are aware of an extremely small number of cases where the fuel cap has not allowed sufficient air to enter the tank during use, creating a vacuum inside the tank and starving the engine of fuel.

All fuel tanks are prone to expansion and contraction as the volume of fuel within them changes. This is predominantly due to a temperature increase of the fuel which causes expansion and takes up a greater volume, or whilst fuel is being consumed, and less fuel remains in the tank over time.

Repeated exposure to excessive pressurisation without correct ventilation can lead to tank degradation, including deformation, splits, and tank ruptures.

An investigation was opened and following an immediate full batch inspection and review, our design engineers identified the OEM valve component at fault and have issued an in-house upgrade to better allow airflow to be drawn into the fuel tank at the optimum rate, avoiding vacuum build-up and fuel starvation to the engine.

This updated fuel cap is a direct replacement and should be immediately fitted to the tank and the old cap discarded.
